ELECTRICAL SAFETY FOLLOW UP INSPECTION REPORT (11TH)

Factory Name	A. K. M. KNIT WEAR LTD.				Note:
Address	14 No. Genda, Karnopara, Ulail, Savar				
FACTORY ID	9178	ELECTRICAL SAFETY INSPECTION DATES			
Initial Inspection Date	24/03/2014	Date of 5 th Follow Up	16/11/2016	Date of 11 th Follow Up	06/02/2019
Report Received Date	02/08/2014	Date of 6 th Follow Up	24/01/2017	Date of 12 th Follow Up	
Date of 1 st Follow Up	13/02/2015	Date of 7 th Follow Up	23/04/2017	Date of 13 th Follow Up	
Date of 2 nd Follow Up	17/01/2016	Date of 8 th Follow Up	23/08/2017	Date of 14 th Follow Up	
Date of 3 rd Follow Up	09/05/2016	Date of 9 th Follow Up	31/01/2018	Date of 15 th Follow Up	
Date of 4 th Follow Up	28/07/2016	Date of 10 th Follow Up	27/06/2018	Date of 16 th Follow Up	
Inspected by		Mehedi Hasan

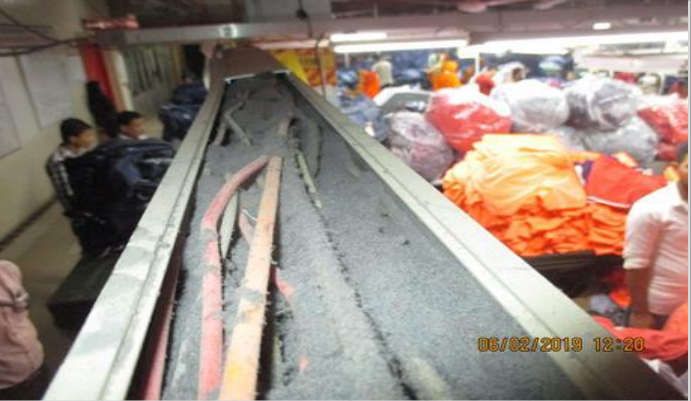
Item No	Accord Inspection Observation	Accord Action Plan (Recommendation)	Accord Time line (given in report)	Comments from Accord (After Physical Inspection)	Final Timeline (Approved timeline)	Final Action Plan (Factory)	Progress Status (On the date of inspection)	Pictorial Evidence
36	New Finding: Multiple cables (came from different electrical consumers) terminated at MCB/MCCB terminals/ Busbar.	Each electrical circuit must be terminated at single MCB/MCCB terminals.	1 Month		25/03/2019			 
37	New Finding: Cable duct/channels are filled with fluffs (Lint/dust).	Cable channels/ducts must be kept neat and clean; these must be sealed properly thus no scope of ingress of fluffs.	1 Month		25/03/2019
