FIRE SAFETY FOLLOW UP INSPECTION

Factory Name	A.K.M. KNIT WEAR LTD.		Accord ID	9178
Address	14 No. Genda, Karnopara, Ulail, Savar			
Inspection Date	24/03/2014		Report Received Date	21/09/2014
Date of 1st Follow-up	13/02/2015	Date of 2nd Follow-up	17/01/2016	
Date of 3rd Follow-up	09/05/2016	Date of 4th Follow-up	28/07/2016	
Date of 5th Follow-up	16/11/2016	Date of 6th Follow-up	24/01/2017	
Date of 7th Follow-up	23/04/2017	Date of 8th Follow-up	23/08/2017	
Date of 9th Follow-up	31/01/2018	Date of 10th Follow-up	27/06/2018	
Date of 11th Follow-up	17/02/2019

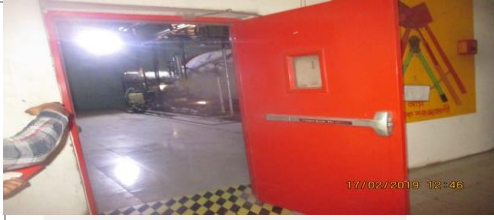
37	The compressor room in ground floor is not separated by fire-rated construction (openings)	Separate the compressor room by a minimum 2-hr fire-rated construction. Seal and or protected all openings to maintain the required fire separations	Within 3 months	On 23/04/2017: In progress. On 23/08/2017: In progress. On 31/01/2018: Work is going on. On 27/06/2018: In progress. On 17/02/2019: Corrected.	'29/02/2016	We have relocated the compressor room at 1st floor of Utility Building from ground floor area & maintained all requirements according to ACCORD standard. (Done).	Corrected

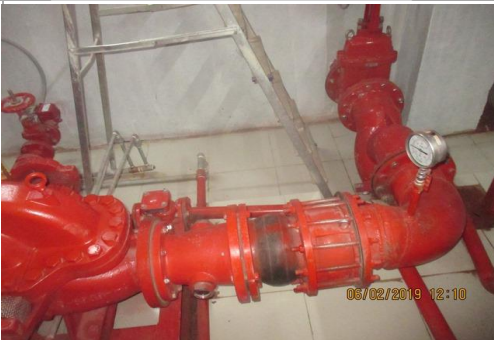
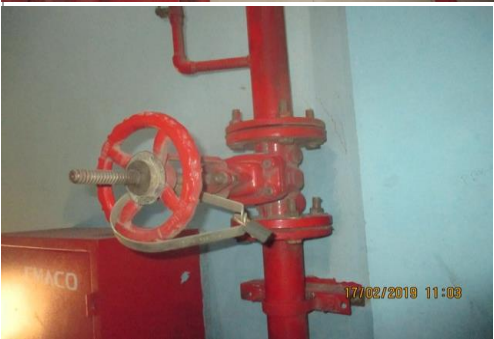
Item No	Accord Inspection Observation	Accord Action Plan (Recommendation)	Accord Timeline (given in report)	Comments from Accord (after Physical Inspection)	Final Approved Timeline (DD/MM/YYYY)	Final Action Plan (Factory)	Progress Status (on the date of Inspection)	Pictorial Evidence
48	New Findings: The existing high-rise building with an occupiable floor greater than 23 m (75 ft) above the finished grade is not protected with an approved automatic sprinkler system. The large occupant loads, heavy fuel loading, and anticipated extended	Provide automatic sprinkler protection throughout the building in accordance with NFPA 13.	Design within 3 months and install within 9 months	<p>On 27/06/2018: T&C observation is incorporated below: Battery trouble was present for the diesel engine fire pump. Operation of fire pump initiates Fire alarm instead of supervisory signal. Flow Meter was present outside the pump room & was not in proper test mood. Diesel tank was undersized. Auto re-fill for fire reservoir shares the domestic supply line. Dedicated water supply for fire fighting shall have to ensure. Fire pump room not separated from the adjacent occupancies. At the store room on 1st & 10th Floor, sprinkler head with K-5.6 has been used instead of K-8. Old hydrant system is still present. I/O module for ZCV was not identified & at several places address of ZCV did not match with the as-built drawing. All the required modification work shall have to be completed as per NFPA-13, 20 & 72.</p> <p>On 17/02/2019: T&C observations (not limited to): Incomplete certification documentation, anti-vortex plate missing, no pump performance test report was found, only pump run is interfaced, no drainage and ventilation in pump room, concentric reducer is used, distance between pump flange and elbow/tee flange is less than 10 diameter of pipe, pressure setting is not proper, negative pressure exceed limit at pump suction side, excessive water leakage from delivery NRV and gaskets, OS&Y valve in Class-I landing valves not electrically supervised, Class-I hose valve has no coupling, sprinkler head is missing at several required locations, coverage area not meet standard at some areas and rooms, sprinkler head spacing is not correct at several locations, head missing under some suspended ceiling areas, hose valve caps were missing.</p> <p>All the deficiencies shall be remediated as soon as possible as per NFPA 13, 14, 20 and 22 prior to acceptance test again.</p>	'30/04/2016	We have completed all tasks according to ACCORD requirements & Guidelines, and waiting for ACCORD verification. (Done)	In Progress

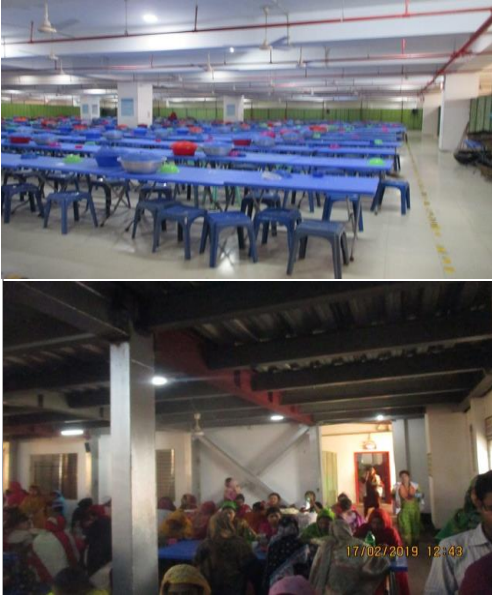
51	New Finding (4th follow up): Dining room is not separated with storage area.	Remove storage or Provide 1 hr. fire separation of dining room with other occupancy.	Within 2 months	On 23/08/2017: In progress. Work shall be completed as per ACCORD standard. On 31/01/2018: Not Corrected yet. On 27/06/2018: It was found same as it was before. On 17/02/2019: Main building dining has been separated from storage however separated dining discharge occupants inside the storage (egress through storage). Additionally utility building dining floor has no separation or partition from accessories building storage floor (door, windows and connection bridge).	'16/12/2016	We have already separated of dining room by providing fire rated wall and fire doors.(Done).	In Progress

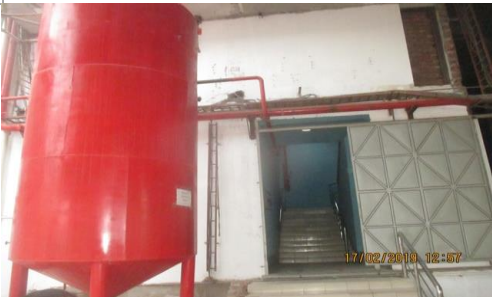
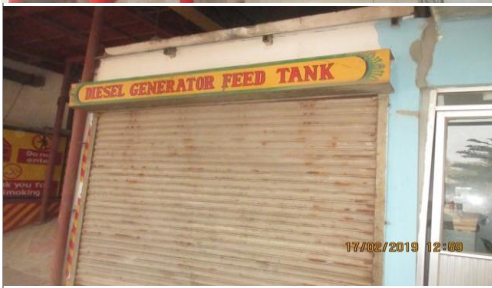
54	New Finding (On 23/04/2017): Hazardous materials/flammable liquid storage area in the ground floor and ground is not separated by fire-rated construction.	Separate the hazardous materials/flammable liquid storage room by a minimum 2-hr fire-rated construction. Seal and or protected all openings to maintain the required fire separations.	Within 1 month	New Finding (On 23/04/2017) . On 23/08/2017: Corrected. On 31/01/2018: Corrected On 27/06/2018: Corrected. On 17/02/2019: Re-opened. Non-rated diesel storage container and storage room is present in front of utility building and not fire separated.	'23/05/2017	Done	In Progress

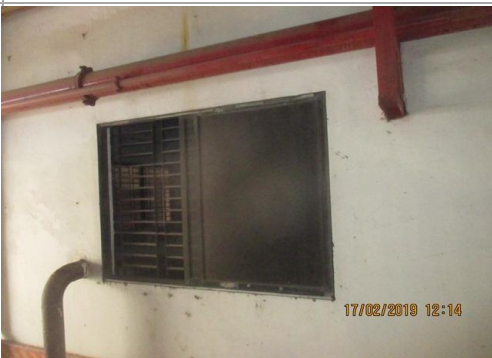
55	New Finding (On 23/04/2017): The exit discharge path is less than 10 ft wide and is not separated from the building interior.	Seal all penetrations and openings to the interior of the building along the discharge path, up to a height of 10 ft. to provide a minimum 1-hr fire separation.	Within 1 month	New Finding (On 23/04/2017). On 23/08/2017: In progress. On 31/01/2018: Modified and now measured 9 ft 7 inch, which is considered corrected based on site observation. On 27/06/2018: Corrected as per previous follow-up. Note: Discharge path width shall not be obstructed which decrease the width of discharge path. On 17/02/2019: Corrected based on previous follow ups. However some window opening still present and shall be sealed.	'23/05/2017	the exit discharge path is now made free of any obstacle .(Done)	Corrected

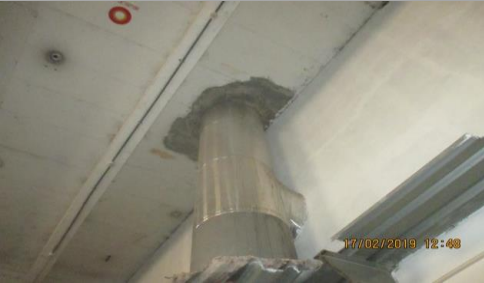
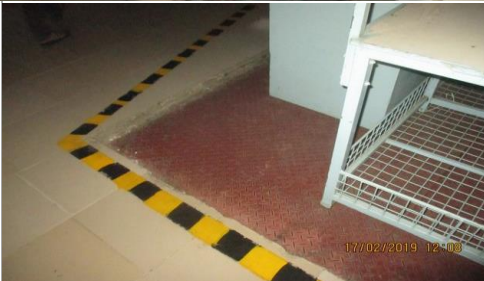
Item No	Accord Inspection Observation	Accord Action Plan (Recommendation)	Accord Timeline (given in report)	Comments from Accord (after Physical Inspection)	Final Approved Timeline (DD/MM/YYYY)	Final Action Plan (Factory)	Progress Status (on the date of Inspection)	Pictorial Evidence
56	New Finding (On 23/04/2017): Unsealed penetrations and openings on several floors are located in the fire-rated floor/ceiling assemblies.	Seal all penetrations and openings in floor/ceiling (full thickness of the floor/ceiling) assemblies by fire rated materials to maintain the fire resistance rating. Provide a minimum 2-hr fire rated shaft to separate the utility risers from each floor if required.	Within 1 month	New Finding (On 23/04/2017) On 23/08/2017: Partially corrected. Work shall be completed as per ACCORD standard. On 31/01/2018: Partially Corrected. Modification work going on. On 27/06/2018: Not corrected. Factory shall separate the lifts (newly constructed) located inside floor area. On 17/02/2019: New lift has been separated. However basement ceiling has non-rated construction on N-W corner of main building. Also non-rated boiler chimney penetrates all floor of utility building.	'23/05/2017	We have sealed all the penetrations & openings. Besides, Separated lift by provided fire rated wall & fire door.(Done)	In Progress

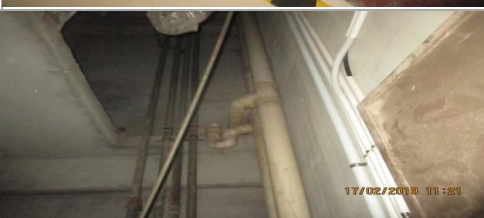
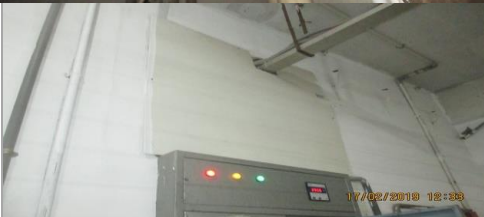
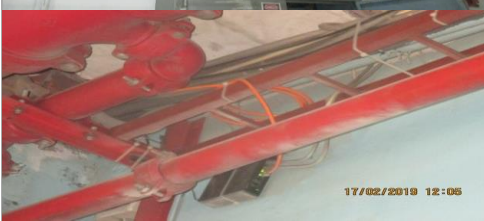
57	New Finding (10th Follow Up): Unsealed penetrations and openings are located in exit stair enclosure (Main building, Stair-1 in Ground floor & window opening in utility building)	Seal all penetrations and openings in the wall of exit enclosure walls (full thickness of the wall) by fire rated materials to maintain the fire resistance rating.	Within 1 month	On 27/06/2018: New Finding On 17/02/2019: N-E stair is not properly separated from accessories building window opening on ground floor of main building. Main building stair-8 is not protected from sanitary shaft opening. Electrical cable riser/raceway penetrates almost all stair enclosures on ground floor of main building which is not permitted. SBD installed by penetrating stairwell of accessories building.	'27/07/2018	We have sealed all penetrations and openings in the wall by fire rated materials and maintained the fire resistance rating. (Done)	In Progress

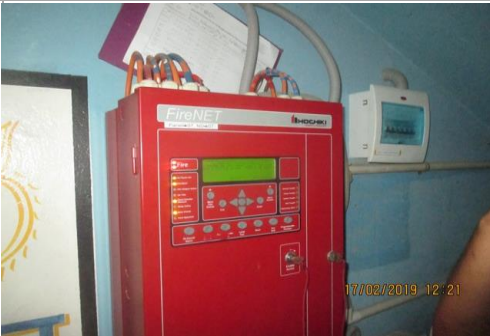
Item No	Accord Inspection Observation	Accord Action Plan (Recommendation)	Accord Timeline (given in report)	Comments from Accord (after Physical Inspection)	Final Approved Timeline (DD/MM/YYYY)	Final Action Plan (Factory)	Progress Status (on the date of Inspection)	Pictorial Evidence
58	New Finding: Installed fire alarm and detection system does not comply with NFPA 72. Alarm signal is not temporal three type, low audibility, MCP not working/responding, detector coverage not to standard, MCP is in stair and more than 5ft in floors, battery calculation and as-built design not up to date, trouble/pre-alarm exist in FACP.	Fire alarm and detection system shall confirm compliant to NFPA 72. After re-configuring the system notify the Accord for a testing and commissioning verification inspection.	Within 2 months		17-04-2019

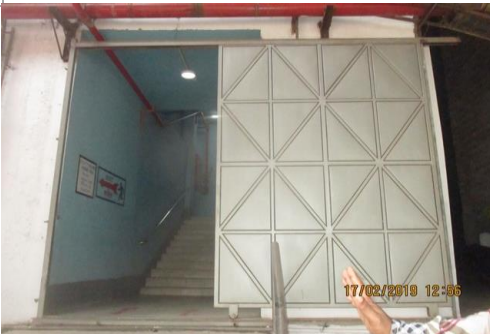
59	New Finding: Non-compliant collapsible gate at main building office portion and sliding gate present at utility building stair discharge on ground floor.	Replace all collapsible/sliding/shutter type doors & gates by the side-hinged swinging type doors. If locks are required for security reasons, utilize special door locking features complying with NFPA 101.	Immediate		20-02-2019

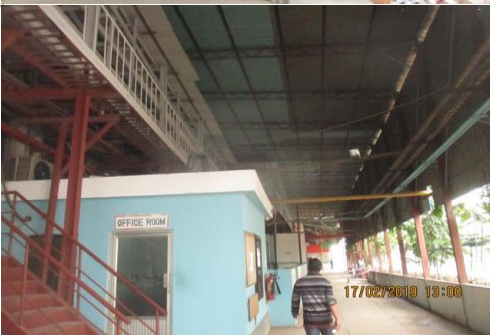
60	New Finding: Front exit stairs of accessories building and utility building is discharge the occupants inside the building. Both building has extended canopy made by steel construction and non-separated utilities, offices and building openings	1. Modify stair to discharge directly outside. Or 2. Provide 2-hr fire-rated exit passageway leading directly outside (vestibules to separate any storage areas). Or 3. Provide sprinkler protection for discharge floor in accordance with NFPA 13.	Within 2 months		17-04-2019

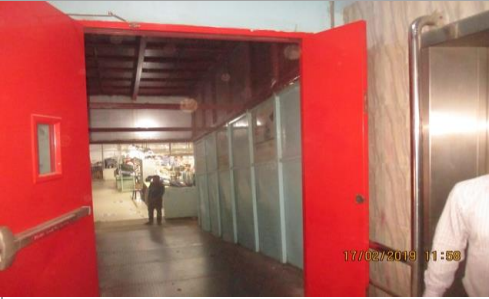
Item No	Accord Inspection Observation	Accord Action Plan (Recommendation)	Accord Timeline (given in report)	Comments from Accord (after Physical Inspection)	Final Approved Timeline (DD/MM/YYYY)	Final Action Plan (Factory)	Progress Status (on the date of Inspection)	Pictorial Evidence
61	New Finding: Some fire doors are not interfaced with FACP and some fire doors has narrower leaf interfaced with FACP without door closer and push bar.	Re-configure fire door installation and interfacing with FACP thus it satisfy standard as well as fire separation integrity.	Within 1 month		17-03-2019

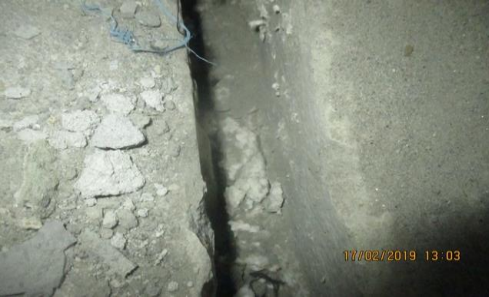
62	New Finding: Building expansion joint opening is not protected by fire rated material.	Seal all penetrations and openings in floor/ceiling (full thickness of the floor/ceiling) assemblies by fire rated materials to maintain the fire resistance rating. Provide a minimum 2-hr fire rated sealant to seal the expansion joint openings from each floor.	Within 2 months		17-04-2019

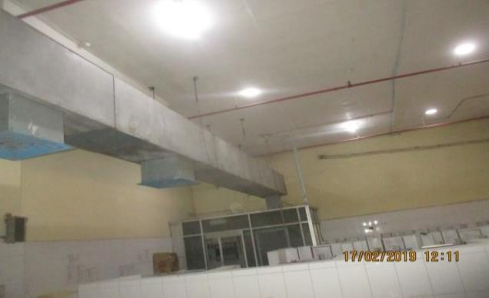
63	New Finding: Non-rated exhaust duct penetration located within separated chemical storage at ground floor.	Re-route the exhaust duct and seal all penetrations and openings in the fire rated separation walls (full thickness of the wall) by fire rated materials to maintain the fire resistance rating.	Within 2 months		17-04-2019
