FIRE SAFETY FOLLOW UP INSPECTION

Factory Name	A.K.M. KNIT WEAR LTD.		Factory ID	9178
Address	14 No. Genda, Karnopara, Ulail, Savar			
Initial Inspection Date	24-Mar-2014		Report Received Date	
Date of 1st Follow-up	13-Feb-2015	Date of 2nd Follow-up	17-Jan-2016	
Date of 3rd Follow-up	09-May-2016	Date of 4th Follow-up	28-Jul-2016	
Date of 5th Follow-up	16-Nov-2016	Date of 6th Follow-up	24-Jan-2017	
Date of 7th Follow-up	23-Apr-2017	Date of 8th Follow-up	23-Aug-2017	
Date of 9th Follow-up	31-Jan-2018	Date of 10th Follow-up	27-Jun-2018	
Date of 11th Follow-up	17-Feb-2019	Date of 12th Follow-up	05-Sep-2021 and 13-Sep-2021

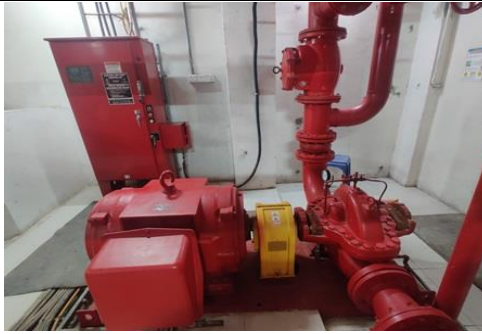
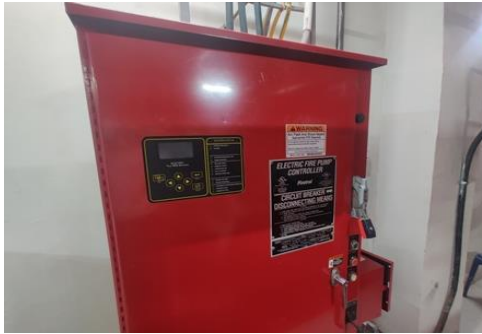
Item No	Inspection Observation	Inspection Action Plan	Inspection Timeline	Inspection Comments	Final Timeline	Factory Action Plan	Progress Status	Pictorial Evidence
48	<p>New Findings: The existing high-rise building with an occupiable floor greater than 23 m (75 ft) above the finished grade is not protected with an approved automatic sprinkler system. The large occupant loads, heavy fuel loading, and anticipated extended</p>	Provide automatic sprinkler protection throught the building in accordance with NFPA 13.	Design within 3 months and install within 9 months	<p>On 27/06/2018: T&C observation is incorporated below: Battery trouble was present for the diesel engine fire pump. Operation of fire pump initiates Fire alarm instead of supervisory signal. Flow Meter was present outside the pump room & was not in proper test mood. Diesel tank was undersized. Auto re-fil for fire reservoir shares the domestic supply line. Dedicated water supply for fire fighting shall have to ensure. Fire pump room not separated from the adjacent occupancies. At the store room on 1st & 10th Floor, sprinkler head with K-5.6 has been used instead of K-8. Old hydrant system is still present. I/O module for ZCV was not identified & at several places address of ZCV did not match with the as-built drawing. All the required modification work shall have to be completed as per NFPA-13, 20 & 72.</p> <p>On 17/02/2019: T&C observations (not limited to): Incomplete certification documentation, anti-vortex plate missing, no pump performance test report was found, only pump run is interfaced, no drainage and ventilation in pump room, concentric reducer is used, distance between pump flange and elbow/tee flange is less than 10 diameter of pipe, pressure setting is not proper, negative pressure exceed limit at pump suction side, excessive water leakage from delivery NRV and gaskets, OS&Y valve in Class-I landing valves not electrically supervised, Class-I hose valve has no coupling, sprinkler head is missing at several required locations, coverage area not meet standard at some areas and rooms, sprinkler head spacing is not correct at several locations, head missing under some suspended ceiling areas, hose valve caps were missing.</p> <p>All the deficiencies shall be remediated as soon as possible as per NFPA 13, 14, 20 and 22 prior to acceptance test again.</p> <p>On 02/07/2019: Not Approved. See the T&C report for details.</p> <p>On 05/Sep/2021: The electrical pump is found out of order. Reportedly all installation work is completed but electrical pump is malfunctioning since 4/5 days.</p>	30-Apr-2016	<p>As per Accord/ RSC instruction, we have completed all tasks & we are ready for T&C of sprinkler system.</p> <p>In addition, In this ID, ACCORD/ RSC covered 5 buildings where all structural issues have been corrected.</p> <p>However, After the initial inspection among five buildings, R&D & Dryprocess buildings are not audited on electrical & fire safety part.</p> <p>Therefore, we are requesting to include R&D & dry process building in the fire & electrical safety part.</p>	In Progress

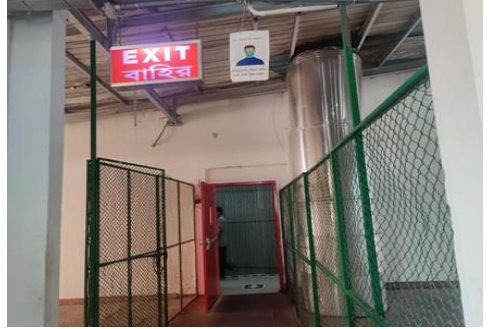
Item No	Inspection Observation	Inspection Action Plan	Inspection Timeline	Inspection Comments	Final Timeline	Factory Action Plan	Progress Status	Pictorial Evidence
51	New Finding (4th follow up): Dining room is not separated with storage area.	Remove storage or Provide 1 hr. fire separation of dining room with other occupancy.	Within 2 months	<p>On 23/08/2017: In progress. Work shall be completed as per ACCORD standard.</p> <p>On 31/01/2018: Not Corrected yet.</p> <p>On 27/06/2018: It was found same as it was before.</p> <p>On 17/02/2019: Main building dining has been separated from storage however separated dining discharge occupants inside the storage (egress through storage). Additionally utility building dining floor has no separation or partition from accessories building storage floor (door, windows and connection bridge).</p> <p>On 05/Sep/2021: Main building and utility building dining has been separated from storage areas/floors however separated dining of both buildings discharge the occupants inside the adjacent storage (egress through storage). Additionally connection bridge is used as egress which is non-rated where rated is required to separate/protect the bridge from lower floor.</p>	16-Dec-2016	We have already separated discharge path of storage by fire rated wall and fire doors. Furthermore, utility building has been separated from accessories building and removed all storage from accessories building. (Pending Verification)	In Progress

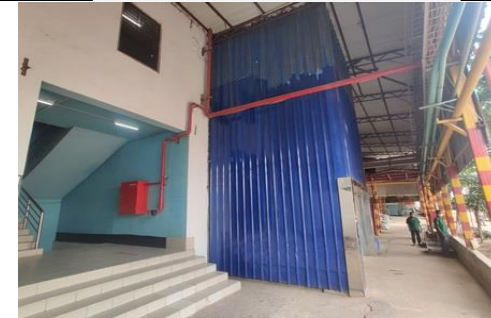
Item No	Inspection Observation	Inspection Action Plan	Inspection Timeline	Inspection Comments	Final Timeline	Factory Action Plan	Progress Status	Pictorial Evidence
54	New Finding (On 23/04/2017): Hazardous materials/flammable liquid storage area in the ground floor and ground is not separated by fire-rated construction.	Separate the hazardous materials/flammable liquid storage room by a minimum 2-hr fire-rated construction. Seal and or protected all openings to maintain the required fire separations.	Within 1 month	<p>New Finding (On 23/04/2017) .</p> <p>On 23/08/2017: Corrected.</p> <p>On 31/01/2018: Corrected</p> <p>On 27/06/2018: Corrected.</p> <p>On 17/02/2019: Re-opened. Non-rated diesel storage container and storage room is present in front of utility building and not fire separated.</p> <p>On 05/Sep/2021: Removed. Not found.</p>	23-May-2017	We have already removed diesel storage container from infront of Utility Building. (Pending Verification)	Corrected

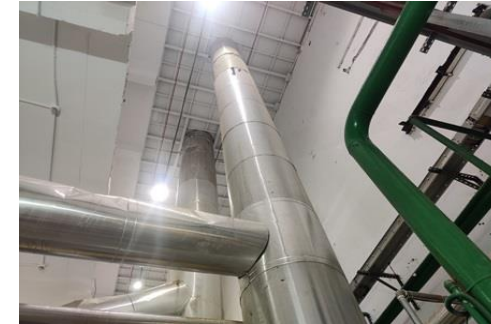
56	New Finding (On 23/04/2017): Unsealed penetrations and openings on several floors are located in the fire-rated floor/ceiling assemblies.	Seal all penetrations and openings in floor/ceiling (full thickness of the floor/ceiling) assemblies by fire rated materials to maintain the fire resistance rating. Provide a minimum 2-hr fire rated shaft to separate the utility risers from each floor if required.	Within 1 month	<p>New Finding (On 23/04/2017)</p> <p>On 23/08/2017: Partially corrected. Work shall be completed as per ACCORD standard.</p> <p>On 31/01/2018: Partially Corrected. Modification work going on.</p> <p>On 27/06/2018: Not corrected. Factory shall separate the lifts (newly constructed) located inside floor area.</p> <p>On 17/02/2019: New lift has been separated. However basement ceiling has non-rated construction on N-W corner of main building. Also non-rated boiler chimney penetrates all floor of utility building.</p> <p>On 05/Sep/2021: Fire rated construction has been provided at basement ceiling on N-W corner of main building. Fire rated shaft has been provided for 2 boiler chimnies among 5 chimnies at utility building.</p>	23-May-2017	As per Accord instruction we have ensure fire rated construction of the basement ceiling by 2 hours concrete slab at N-W corner of main building. And utility riser also separated and protected by fire rated materials. (Pending Verification	In Progress

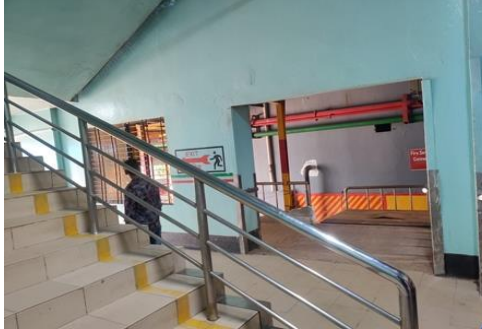
Item No	Inspection Observation	Inspection Action Plan	Inspection Timeline	Inspection Comments	Final Timeline	Factory Action Plan	Progress Status	Pictorial Evidence
57	New Finding (10th Follow Up): Unsealed penetrations and openings are located in exit stair enclosure (Main building, Stair-1 in Ground floor & window opening in utility building)	Seal all penetrations and openings in the wall of exit enclosure walls (full thickness of the wall) by fire rated materials to maintain the fire resistance rating.	Within 1 month	On 27/06/2018: New Finding On 17/02/2019: N-E stair is not properly separated from accessories building window opening on ground floor of main building. Main building stair-8 is not protected from sanitary shaft opening. Electrical cable riser/raceway penetrates almost all stair enclosures on ground floor of main building which is not permitted. SBD installed by penetrating stairwell of accessories building. On 05/Sep/2021: N-E stair is not properly separated from accessories building window opening on ground floor of main building. Cable (electrical/optical) riser/raceway penetrates several stair enclosures on ground floor of main building which is not permitted.	27-Jul-2018	We have separated stairs properly and closed window opening of ground floor building, sanitary shaft opening sealed by fire rated wall, Electrical cable riser /raceway penetration sealed by fire rated materials of all building & Sub Distribution Board set up as per ACCORD/ RSC instruction, we have completed all tasks & we are ready for T&C of fire alarm & detection system. In addition, In this ID, ACCORD/ RSC covered 5 buildings where all structural	In Progress

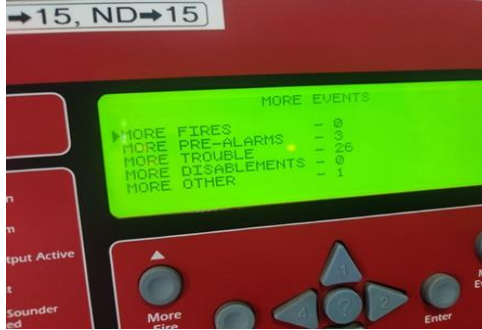
58	New Finding: Installed fire alarm and detection system does not comply with NFPA 72. Alarm signal is not temporal three type, low audibility, MCP not working/responding, detector coverage not to standard, MCP is in stair and more than 5ft in floors, battery calculation and as-built design not up to date, trouble/pre-alarm exist in FACP.	Fire alarm and detection system shall confirm compliant to NFPA 72. After re-configuring the system notify the Accord for a testing and commissioning verification inspection.	Within 2 months	On 05/Sep/2021: reportedly modification is completed however system is found unhealthy condition with lots of trouble/pre alarm/supervisory in FACP and repeater panels.	17-Apr-2019		In Progress

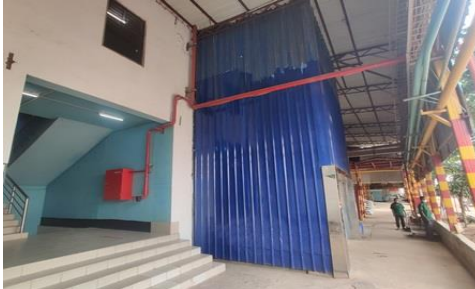
60	New Finding: Front exit stairs of accessories building and utility building is discharge the occupants inside the building. Both building has extended canopy made by steel construction and non-separated utilities, offices and building openings present there.	1. Modify stair to discharge directly outside. Or 2. Provide 2-hr fire-rated exit passageway leading directly outside (vestibules to separate any storage areas). Or 3. Provide sprinkler protection for discharge floor in accordance with NFPA 13.	Within 2 months	On 05/Sep/2021: Found almost same as before. N-E exit of main building also discharge the occupant under the extended canopy.	17-Apr-2019	We have ensured separate discharge passageway of occupants at Accessories and Utility Building. At the extended canopy area, we have ensured AFDS. (Pending Verification)	In Progress

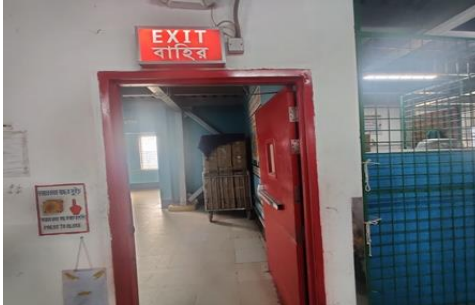
Item No	Inspection Observation	Inspection Action Plan	Inspection Timeline	Inspection Comments	Final Timeline	Factory Action Plan	Progress Status	Pictorial Evidence
61	New Finding: Some fire doors are not interfaced with FACP and some fire doors has narrower leaf interfaced with FACP without door closer and push bar.	Re-configure fire door installation and interfacing with FACP thus it satisfy standard as well as fire separation integrity.	Within 1 month	On 05/Sep/2021: Corrected.	17-Mar-2019	All fire doors have been interfaced with FACP and ensure with door closer and push bar according to ACCORD recommendation s. (Pending Verification)	Corrected

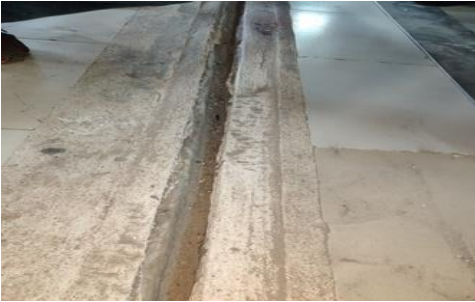
62	New Finding: Building expansion joint opening is not protected by fire rated material.	Seal all penetrations and openings in floor/ceiling (full thickness of the floor/ceiling) assemblies by fire rated materials to maintain the fire resistance rating. Provide a minimum 2-hr fire rated sealant to seal the expansion joint openings from each floor.	Within 2 months	On 05/Sep/2021: Reportedly listed material is used to seal the joint however product sample/package/drum is not provided to check UL certification mark and classification mark on the product also application is not as per UL certified design.	17-Apr-2019	We have already sealed the building expansion join by fire-rated materials to maintain the fire-resistance rating of each floor, the work is fully completed. (Pending Verification)	In Progress

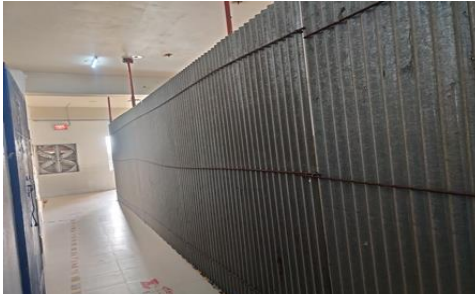
64	New Finding: Utility building dining floor exit capacity is not adequate for the occupant load. Dining capacity more than 500 and provided with only 2 exit.	1. Reduce occupant load to not more than available exit capacity as per Accord 6.5.4 and 6.6.3. Or 2. Provide additional exits to increase exit capacity as per Accord 6.5.4 and 6.6.3.	Within 1 month	On 05/Sep/2021: Additional 2 exit is provided for the utility building dining. See issue 51 for access to stair/egress discharge feature.	17-Mar-2019	To ensure adequate departure, we have added two additional egress door at the utility building and now four exits can be use to depart from the dining hall. (Pending Verification)	Corrected

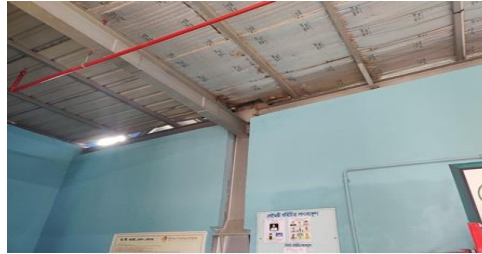
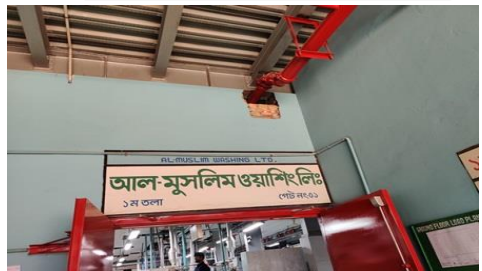
Item No	Inspection Observation	Inspection Action Plan	Inspection Timeline	Inspection Comments	Final Timeline	Factory Action Plan	Progress Status	Pictorial Evidence
65	<p>New Finding (12th follow up): The exit stairs are not separated from work areas, other spaces on each floor by fire-rated construction.</p> <p>(Location: Dry process and R&D building. Fire doors are provided however door hardware missing/not working and unprotected opening/penetration observed.)</p>	<p>Stair shall be enclosed with a minimum 1-hr fire-rated construction. Seal all unprotected openings and provide minimum 1-hr fire rated doors to separate the exit stairs from work areas and other building spaces on all floor levels. Ensure that the fire doors are self-closing, positive latching and that they are provided with fire exit (panic) hardware where serving production floors.</p> <p>If fire doors are required to be held open for functional reasons, provide automatic-closing devices tied to the fire alarm system.</p>	Within 2 months	On 13/Sep/2021: Both buildings are added in the scope of fire safety followup inspection.	13-Nov-2021

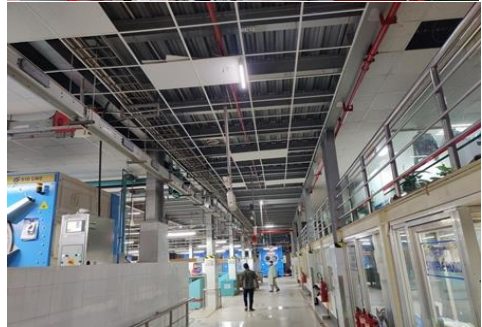
66	<p>New Finding (12th follow up): Existing 3 story non-rated building (dry process building) having floor area more than 2000 sqm (22000 sft) is required to be protected with an approved automatic sprinkler system where sprinkler installation is going on. Automatic sprinkler system installation requires detailed review to confirm compliance with NFPA 20 and ACCORD standards.</p>	<p>Install an automatic sprinkler protection throughout the building in accordance with NFPA 13. Before that, Submit the drawings, equipment certification and other relevant documentation to the RSC for review and approval.</p>	Design within 1 months, install within 3 months		13-Jan-2022

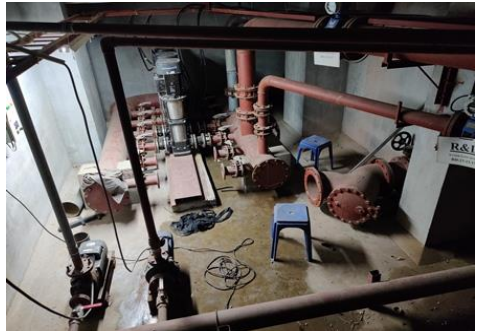
67	<p>New Finding (12th follow up): The water pump room is located within the exit stair enclosure at dry process building and not provided with adequate fire separation from the stair.</p>	<p>Separate the water pump room by minimum 1-hr fire-rated construction.</p> <p>If factory wants to provide pump room exit within the exit stair then vestibule shall be provided. If required, provide a 1 hr fire rated door on the exit stair side and a 1-hr fire rated door on the water pump room side. Ensure that the fire rating of the vestibule construction matches that of the exit stair enclosure.</p>	Within 2 months		13-Nov-2021
