Structural Safety Inspection

Factory Name	A.K.M. KNIT WEAR LTD.	Accord ID	9178
Factory Address	14 No. Genda, Karnopara, Ulail, Savar		
Inspection Date	02-Apr-2014		
Date of Review Inspection	21-Aug-19		
Inspected by	Md. Abu Zafar-Al-Mansur & Mucedul Islam

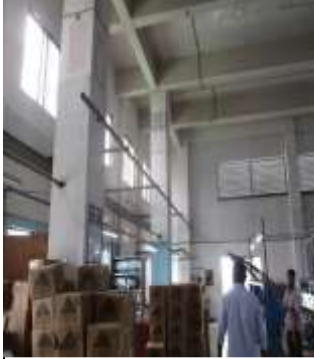
Item No	Accord Observation	Accord Recommendation	Accord Timeline	Final Action Plan	Final Timeline(DD /MM/YYYY)	Comments after Physical Inspection	Progress Status	Pictorial Evidence
3	Steel infill floor in 4 Storey structure is constructed independent of the main concrete structure.	Provide calculations showing the structural adequacy of all supports for steel infill floor including wall and slab supports. Stability of the steel structure to be confirmed by calculation by Engineer.	(within 6-months)	Steel infill floor in this building is being demolished.	14-Aug-2014	<p>On 13/02/2015: As above.</p> <p>On 21/07/2016: This issue will be covered in DEA report. Factory management submitted their DEA report to ACCORD which is under review.</p> <p>On 23/04/2017: This issue is required to be covered in DEA. Factory management submitted DEA report to ACCORD on 16th March 2017 and it is under review.</p> <p>On 23/08/2017: This issue is required to be covered in DEA. Revised DEA of Utility building and Steel Structures has been submitted to Accord on 30 Aug 2017 which is in under review.</p> <p>On 03/04/2018: Steel infill floor in utility building was found demolished.</p> <p>On 31/07/2018: Corrected in previous inspection.</p> <p>On 6th Feb 2019 & 17th Feb 2019: Corrected from previous inspection.</p> <p>On 21st Aug-2019: Corrected from previous inspection. Steel infill floor in utility building was found demolished.</p>	Corrected

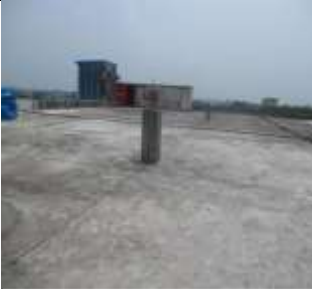
Item No	Accord Observation	Accord Recommendation	Accord Timeline	Final Action Plan	Final Timeline(DD /MM/YYYY)	Comments after Physical Inspection	Progress Status	Pictorial Evidence
7	Exposed Reinforcement.	Exposed reinforcement should be protected with suitable resin	(within 6-months)	Exposed reinforcement has been made protected.	14-Aug-2014	<p>On 13/02/2015: They have protected exposed reinforcement.</p> <p>On 21/07/2016: Corrected in 1st follow up; found same in current.</p> <p>On 23/04/2017: Corrected in the 1st follow up inspection.</p> <p>On 23/08/2017:Corrected in 1st follow up; found same in current.</p> <p>On 03/04/2018: Corrected from previous inspection. Found same during inspection.</p> <p>On 31/07/2018: Corrected in previous inspection.</p> <p>On 6th Feb 2019 & 17th Feb 2019: Corrected from previous inspection.</p> <p>On 21st Aug-2019: Corrected from previous inspection. Exposed reinforcement has been removed.</p>	Corrected

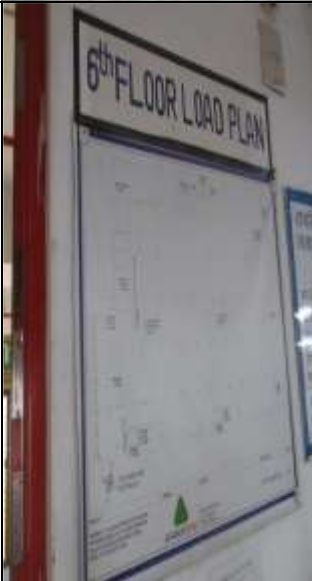
8	Management of storage loads	Produce and actively manage a loading plan for all floor plates within the factory giving consideration to floor capacity and column capacity.	(within 6-weeks)	This issue has been included in EA of Utility building. EA of Utility building has been re-approved by Accord on 27th December, 2018. No remediation is required for RCC portion of the building. We are waiting for Accord verification. (Corrected)	14-Aug-2014	<p>On 13/02/2015: This issue will cover under DEA.</p> <p>On 21/07/2016: Load plan found prepared & posted to each floor. Factory management submitted their DEA report to ACCORD which is under review. So this issue will be covered in DEA.</p> <p>On 23/04/2017: Load plan has been prepared and posted but not approved from ACCORD yet. During inspection overall loading found below 3 kpa. Factory management submitted DEA report to ACCORD on 16th March 2017 and it is under review.</p> <p>On 23/08/2017: Load plans of Main factory building & Accessories building have been accepted along with DEA by Accord. During inspection, load plan were posted on each floor and maintained accordingly. Load plans of Utility building and Steel Structure were prepared as a part of DEA which were not finalized yet. Revised DEA of Utility building and Steel Structures has submitted to Accord on 30 Aug 2017 which is in under review.</p> <p>On 03/04/2018: Load plans had been prepared and accepted for main factory building & accessories building on 30/08/2017. During inspection load plans were found posted to all building but load plans of utility building and all steel structures were prepared as a part of DEA which were not finalized yet. Factory management submitted another submission on 08/03/2018 and got a review mail from ACCORD for utility building, dry process building and R & D building on 29/03/2018. So factory was required to submit revised DEA within 12/04/2018.</p> <p>On 31/07/2018: Load plan has been prepared as a part of DEA. DEA report for Utility building, Dry process building, and R & D building have been reviewed and accepted by Accord on 22 July 2018. All the retrofitting works are required to be completed by September 15, 2018. During inspection some discrepancies were found in as-built drawings. Factory is required to revise the documents as per DEA verification report and submit to Accord within mentioned time-line. However, floor loading was found below 42 psf (except dining) in the time of inspection.</p> <p>On 6th Feb 2019 & 17th Feb 2019: Load plan has been produced and accepted as a part of DEA. During inspection accepted load plan was found posted at every floor and load was found below allowable limit (42 psf).</p> <p>On 21st Aug-2019: Corrected from previous inspection. Load plan has been produced and accepted as a part of DEA. During inspection accepted load plan was found posted at every floor and load was found below allowable limit (42 psf).</p>	Corrected

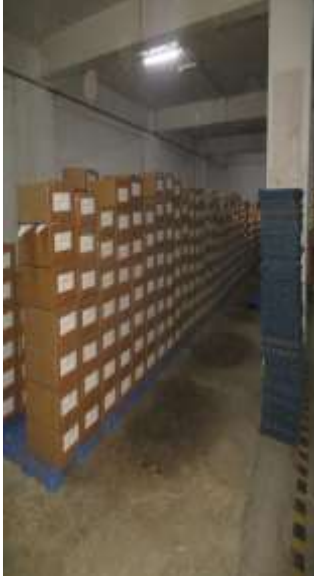
Item No	Accord Observation	Accord Recommendation	Accord Timeline	Final Action Plan	Final Timeline(DD /MM/YYYY)	Comments after Physical Inspection	Progress Status	Pictorial Evidence
9	Management of storage loads	Continue to implement load management plan	(within 6-months)	This issue has been included in EA of Utility building. EA of Utility building has been re-approved by Accord on 27th December, 2018. No remediation is required for RCC portion of the building. We are waiting for Accord verification.(Corrected)	30-Dec-2014	<p>On 13/02/2015: This issue will cover under DEA.</p> <p>On 21/07/2016: Load plan found prepared & posted to each floor. During inspection high loading not observed. Overall loading found satisfactory.</p> <p>On 23/04/2017: Load plan has been prepared and posted but not approved from ACCORD yet. During inspection overall loading found below 3 kpa. Factory management submitted DEA report to ACCORD on 16th March 2017 and it is under review.</p> <p>On 23/08/2017: Load plans of Main factory building & Accessories building have been accepted along with DEA by Accord. During inspection, load plan were posted on each floor and maintained accordingly. Load plans of Utility building and Steel Structure were prepared as a part of DEA which were not finalized yet. Revised DEA of Utility building and Steel Structures has been submitted to Accord on 30 Aug 2017 which is in under review.</p> <p>On 03/04/2018: Load plans had been prepared and accepted for main factory building & accessories building on 30/08/2017. Overall loading was found within the acceptable limit. During inspection load plans were found posted to all building but load plans of utility building and all steel structures were prepared as a part of DEA which were not finalized yet. Factory management submitted another submission on 08/03/2018 and got a review mail from ACCORD for utility building, dry process building and R & D building on 29/03/2018. So factory was required to submit revised DEA within 12/04/2018.</p> <p>On 31/07/2018: Load plan has been prepared as a part of DEA. DEA report for Utility building, Dry process building, and R & D building have been reviewed and accepted by Accord on 22 July 2018. All the retrofitting works are required to be completed by September 15, 2018. During inspection some discrepancies were found in as-built drawings. Factory is required to revise the documents as per DEA verification report and submit to Accord within mentioned time-line. However, floor loading was found below 42 psf (except dining) in the time of inspection.</p> <p>On 6th Feb 2019 & 17th Feb 2019: Load plan has been produced and accepted as a part of DEA. During inspection accepted load plan was found posted at every floor and load was found below allowable limit (42 psf)</p> <p>On 21st Aug-2019: Corrected from previous inspection. During inspection accepted load plan was found posted at every floor and load was found below allowable limit (42 psf).</p>	Corrected

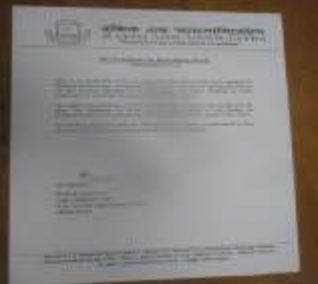
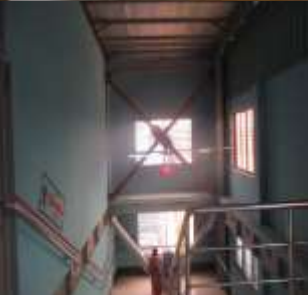
Item No	Accord Observation	Accord Recommendation	Accord Timeline	Final Action Plan	Final Timeline(DD /MM/YYYY)	Comments after Physical Inspection	Progress Status	Pictorial Evidence
11	Stability and connections in steel structures	Building Engineer to provide calculations to prove adequacy of as-built structures. Stability of all steel structures to be reviewed and upgraded where required. All connections in steel structures to be checked and upgraded where required.	(within 6-weeks)	As-built EA of Dry process building has been re-approved on 12th, May 2019. No remediation is required. We are waiting for Accord verification.(Corrected)	14-Aug-2014	<p>On 13/02/2015: This issue will cover under DEA.</p> <p>On 21/07/2016: This issue will be covered in DEA report. Factory management submitted their DEA report to ACCORD which is under review.</p> <p>On 23/04/2017: This issue is required to be covered in DEA report. Factory management submitted DEA report to ACCORD on 16th March 2017 and it is under review.</p> <p>On 23/08/2017: This issue is required to be covered in DEA. Revised DEA has been submitted to Accord on 30 Aug 2017 which is in under review.</p> <p>On 03/04/2018: This issue is required to be covered in DEA. DEA of Main factory building (Basement +11 story) & Accessories building(6 stories) have been accepted by Accord on 28 May 2017. After that factory management submitted another submission on 08/03/2018 and got a review mail from ACCORD for utility building, dry process building and R & D building on 29/03/2018. So factory was required to submit revised DEA within 12/04/2018.</p> <p>On 31/07/2018: This issue has been covered in DEA. DEA report for Utility building, Dry process building, and R & D building have been reviewed and accepted by Accord on 22 July 2018. All the retrofitting works are required to be completed by September 15, 2018. During inspection some discrepancies were found in as-built drawings. Factory is required to revise the documents as per DEA verification report and submit to Accord within mentioned time-line.</p> <p>On 6th Feb 2019 & 17th Feb 2019: DEA report for utility building, Dry process building and R & D building were accepted from ACCORD on 22th July, 2018. The factory got re-acceptance from ACCORD on 27th December, 2018 as discrepancy was found during DEA verification inspection. And the remediation time line was 31st January, 2019. During last inspection some mismatch was found in the retrofitting work of Dry process building. Bracing arrangements was not matched with re-accepted retrofitting drawing. The factory is required to complete the retrofitting as per accepted drawing.</p> <p>On 21st Aug-2019: This issue has been covered in DEA for Dry process Building which has been re-accepted from Accord on 12th May 2019. Factory has completed all remediation works as per re-accepted DEA. Retrofitting completion certificate has also been provided by the factory consultant.</p>	Corrected

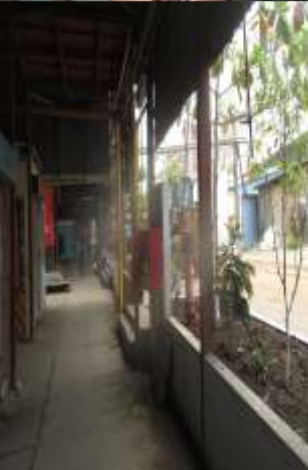
12	Stability of lightweight steel canopy adjacent to Utility Building	Lightweight steel canopy should be reviewed by the Building Engineer and, if required, upgraded to support code vertical and wind loads or the area should be vacated and removed.	(within 6-weeks)	This issue has been included in EA of Steel Structures. EA of Steel Structures has been re-approved by Accord on 27th December, 2018. Remediation work of steel structures has been completed on 12th January, 2019. We are waiting for Accord verification.(Corrected)	14-Aug-2014	<p>On 13/02/2015: This issue will cover under DEA.</p> <p>On 21/07/2016: This issue will be covered in DEA report. Factory management submitted their DEA report to ACCORD which is under review.</p> <p>On 23/04/2017: This issue is required to be covered in DEA. Factory management submitted DEA report to ACCORD on 16th March 2017 and it is under review.</p> <p>On 23/08/2017: This issue is required to be covered in DEA. Revised DEA has been submitted to Accord on 30 Aug 2017 which is in under review.</p> <p>On 03/04/2018: This issue is required to be covered in DEA. DEA of Main factory building (Basement +11 story) & Accessories building(6 stories) have been accepted by Accord on 28 May 2017. After that factory management submitted another submission on 08/03/2018 and got a review mail from ACCORD for utility building, dry process building and R & D building on 29/03/2018. So factory was required to submit revised DEA within 12/04/2018.</p> <p>On 31/07/2018: DEA report for Utility building (including canopy), Dry process building, and R & D building have been reviewed and accepted by Accord on 22 July 2018. All the retrofitting works are required to be completed by September 15, 2018. During inspection some discrepancies were found in as-built drawings. Factory is required to revise the documents as per DEA verification report and submit to Accord within mentioned time-line.</p> <p>On 6th Feb 2019 & 17th Feb 2019: DEA has been reviewed and re-accepted from Accord on 27th Dec 2018. During inspection some discrepancies have been found between as-built drawing and as-built condition. After that factory has updated the as-built drawing which has been reviewed and found acceptable.</p> <p>On 21st Aug-2019: Corrected from previous inspection. DEA has been reviewed and re-accepted from Accord on 27th Dec 2018. Factory has completed remediation works as per drawing.</p>	Corrected

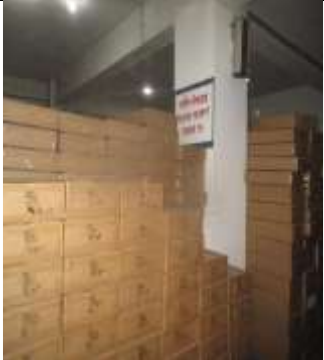
15	Management of storage loads	Continually inspect floor plates based on load plans and reduce loading if necessary.	(within 6-months)	Load plan along with DEA of Main Building and Accessories Building has been approved by Accord approved by Accord on 28th May, 2017. We have posted the approved load plan on floor areas.	30-Dec-2014	<p>On 13/02/2015: This issue will cover under DEA.</p> <p>On 21/07/2016: Load plan found prepared & posted to each floor. During inspection high loading not observed. Overall loading found satisfactory. Factory management submitted their DEA report to ACCORD which is under review.</p> <p>On 23/04/2017: Load plan has been prepared and posted but not approved from ACCORD yet. During inspection overall loading found below 3 kpa. This issue is required to be covered in DEA. Factory management submitted DEA report to ACCORD on 16th March 2017 and it is under review.</p> <p>On 23/08/2017: Load plans of Main factory building have been accepted along with DEA by Accord. During inspection, load plan were posted on each floor and maintained accordingly.</p> <p>On 03/04/2018: Corrected in previous follow up inspection. Load plans had been prepared and accepted for main factory building & accessories building on 30/08/2017. During inspection load plans were found posted on each floor of maintained accordingly.</p> <p>On 31/07/2018: Corrected in previous inspection.</p> <p>On 6th Feb 2019 & 17th Feb 2019: Corrected from previous inspection.</p> <p>On 21st Aug-2019: Corrected from previous inspection. Load plan has been produced and accepted as a part of DEA. During inspection accepted load plan was found posted at every floor and load was found below allowable limit (42 psf).</p>	Corrected
